Appl. No. 09/681,571
Amdt. Dated 3 January 2005
Reply to Office action of 4 October 2004
Attachment

ELECTROMAGNETIC AND ELECTROMECHANICAL MACHINES

Third Edition

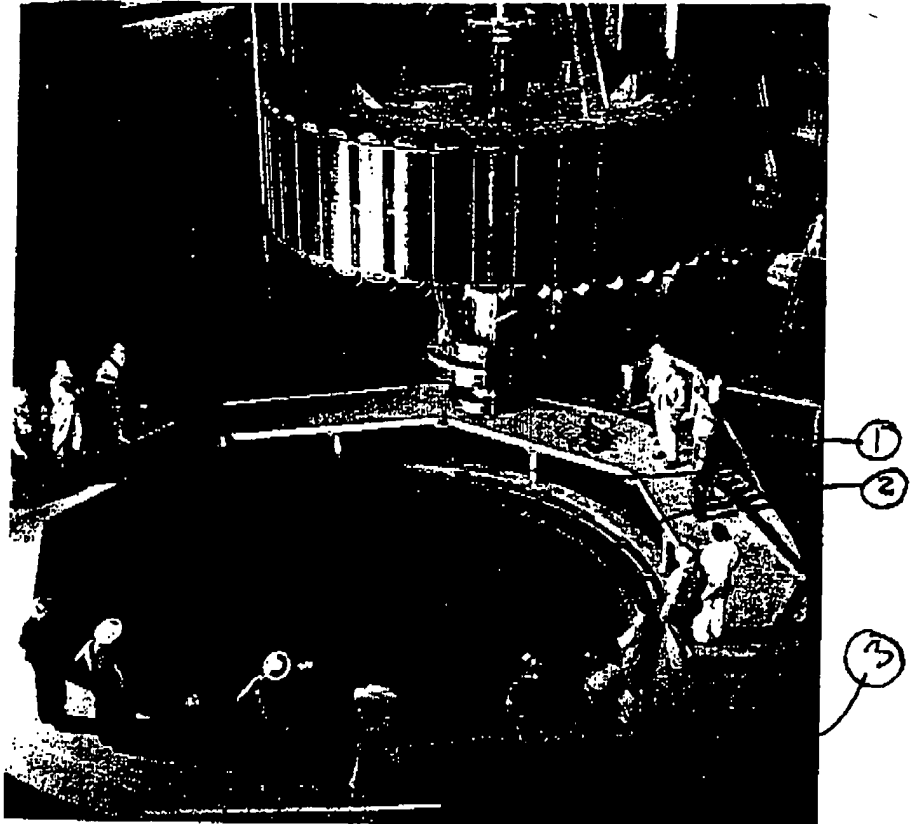
Figure 4-3 Salient-pole rotor being lowered into the stator of a hydrogenerator. (Courtesy General Electric Company.)
